Technical bulletin No.	<b>TB/005</b>	Issue No.	<b>002</b>
Date:	<b>13 March 2009</b>		
Associated bulletin No.	N/A	Issue No.	N/A
Eminox Part Number Ref.	<b>QM1136 (All variants)</b>		
Associated Part Number Ref.			
Distribution	<b>All workshops</b>

**Subject: Changing ESI unit and wiring harness.**

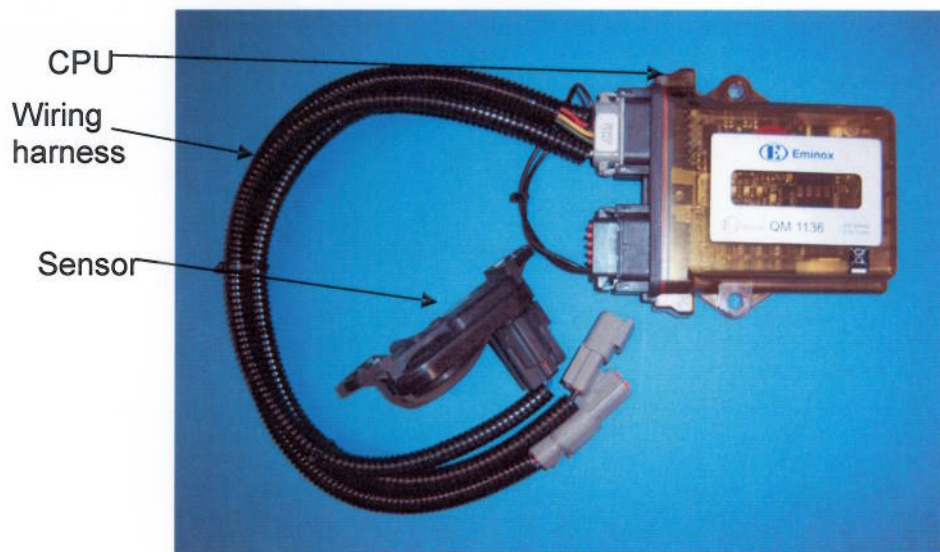
The ESI (Electronic Service Indicator) consists of a central processor unit (CPU), wiring harness and sensor (see attached photo).

The CPU, wiring harness and sensor are matched together, therefore they **must not** be split.

If the ESI becomes faulty or is replaced under warranty the CPU, wiring harness and sensor must be replaced together and returned to Eminox. The replacement part will consist of all three items.

Swapping only part of the unit will invalidate your warranty.
